Title: TRAVERSE and ASCENT underperforming

Affected Bikes: - all Traverse with M400 motor and Rhino battery
- all Ascent with M400 motor and Rhino battery

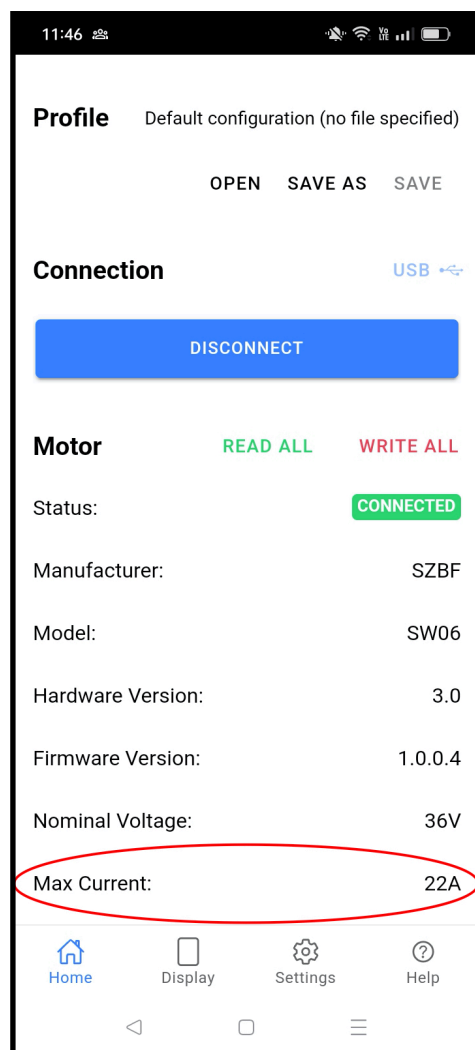
Reason: Bikes underperforming due to wrong Controller Firmware and/or Assist Level Settings

In Menu “Home” the Max Current should show 22A (see picture below).

If the Max Current shows 20A, the firmware needs to be updated (contact your Service Manager).

Corrective Action: CONTROLLER FIRMWARE

Check version of controller firmware with SPEED App.
