# MeloYelo E-Bikes NZ Torque Sensor Replacement, Hub motor bikes

## Why this operation would be needed:

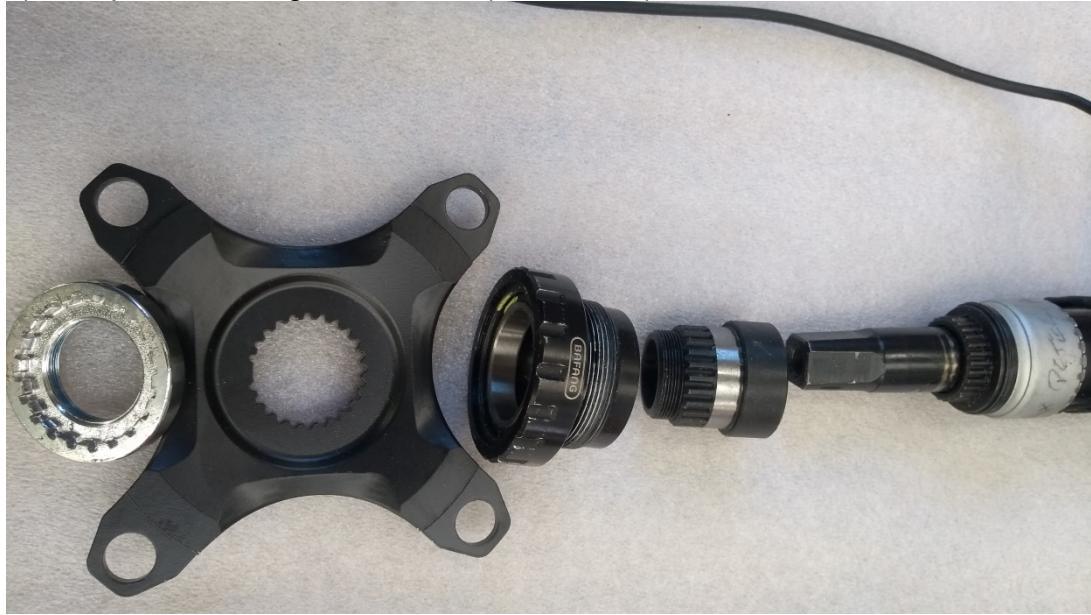
### 1) Components at right hand end (Chain side)

Chromed ring, Chainring hub, bearing housing, splined hub, torque sensor.

2) Remove the chromed ring that retains the chainring hub (Note: the chromed ring has a left-hand (reverse) thread) and remove the chainring;

3) Remove the right-hand bearing housing (chain side) (Note: The right-hand housing has a left-hand (reverse) thread);

11) Wipe a smear of antiseize or grease onto the splined hub where the right-hand bearing will sit, then fit the right-hand bearing housing and tighten it fully against the frame (remember the left-hand thread).

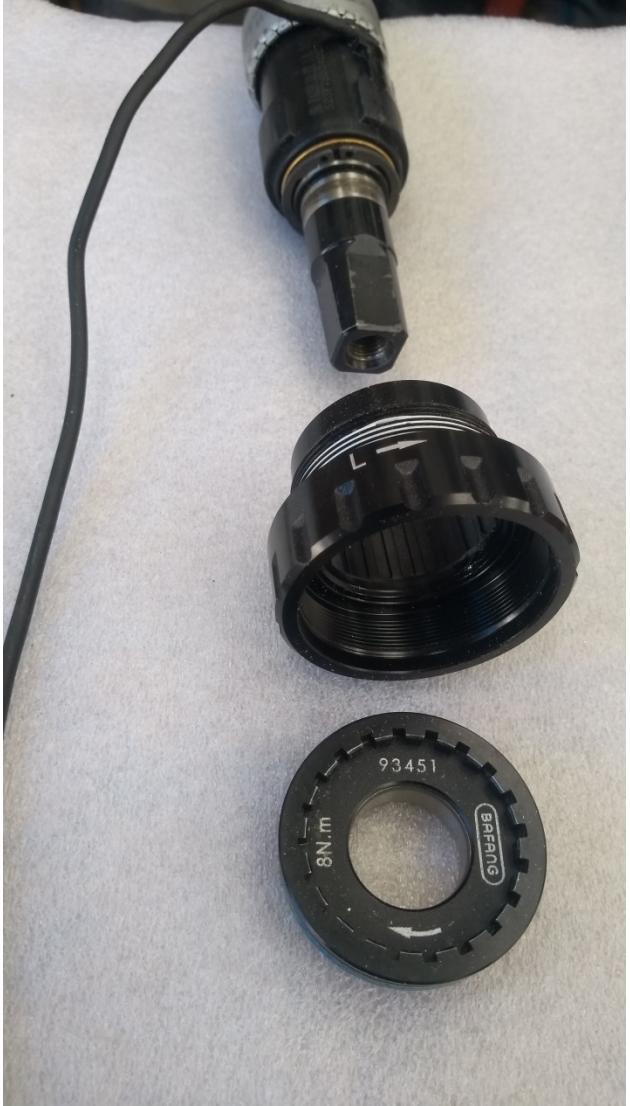
# 2) Components at Left hand side

Torque sensor, housing, bearing assembly.

6) Wind out the left-hand bearing assembly a few turns or remove it completely (Note: it has a right-hand (normal) thread);

8) If the Left-hand housing has been removed, refit it now (Note: the left-hand housing has a right-hand (normal) thread). Check that the housing is tightened firmly against the frame. Remember NOT to turn this housing from now on! Mark it if needed to remind you. If the left-hand bearing assembly has been removed, refit it now, but only screw it in a couple of turns.

12) Push the torque sensor hard to the right and screw in the left-hand bearing assembly unit until the bearing just touches the step in the shaft. There should be no side-play in the sensor shaft, but the bearings must not have any side force applied or they will be damaged.

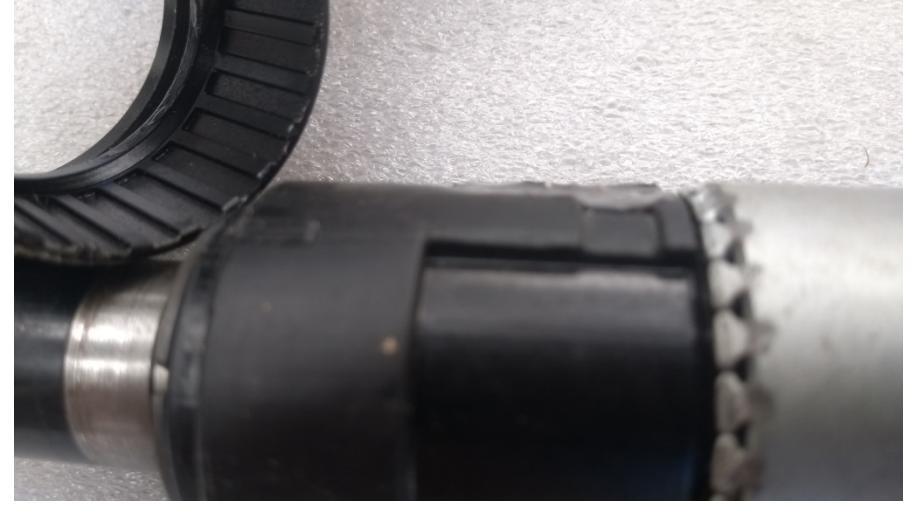
3) Inside LH housing (slots), outside of Torque Sensor (raised keys)

Enter the pedal shaft into the left-hand bearing, and push the sensor body into the left-hand housing. A few raised plastic keys on the outside of the sensor slide into matching slots on the inside of the housing, so you might have to rotate the sensor body slightly to align them. Do not force the sensor if it doesn't slide in fully at first. The point where the cable exits the torque sensor body does not need to be exactly aligned with the hole in the frame, but should be fairly close.

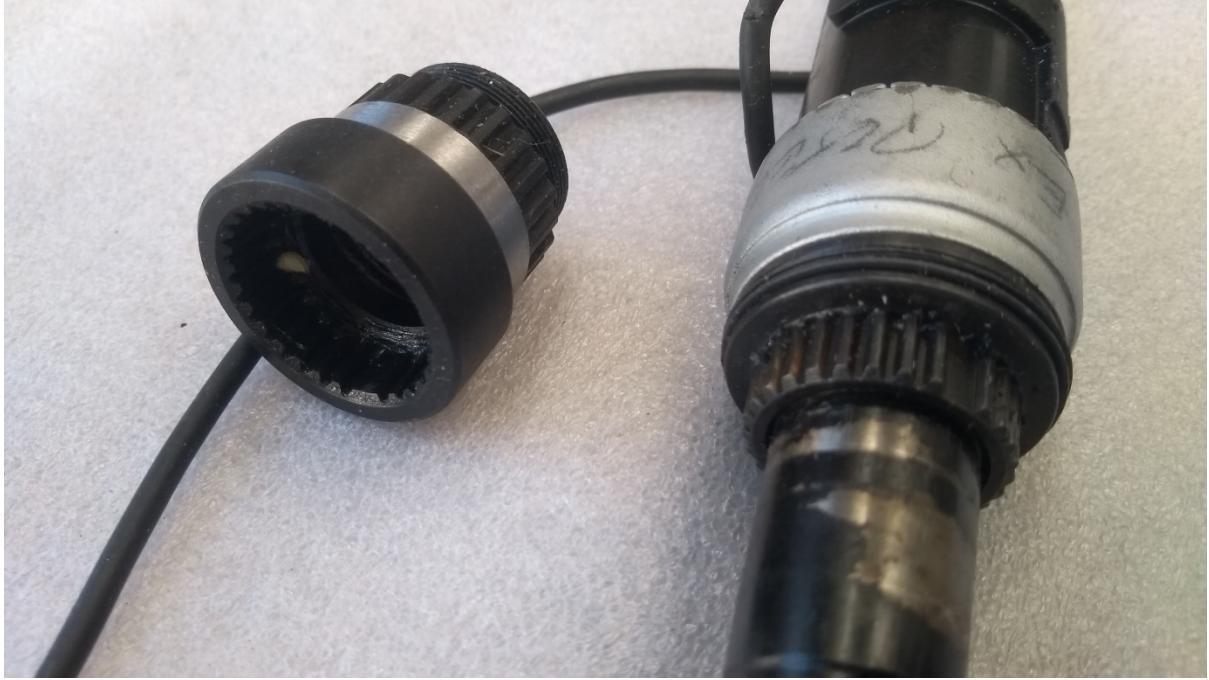
4) Splined hub and torque sensor spline (Note the wide spline in both components)

9) Put a smear of antiseize compound or grease on the pedal shaft of the new sensor where the left-hand bearing will sit, and where the splined hub will sit at the right-hand end. Slide the splined hub onto the sensor and fully engage it onto the spline of the sensor.

**Note:** This spline will only engage in one exact position... the external spline has one wide ridge, and there is a matching wide groove in the internal spline in the hub. These must line up or you will not be able to engage the splines. Even when correctly aligned, this spline is a bit stiff / notchy to assemble, so it is much easier to do it now when you can see both parts easily;

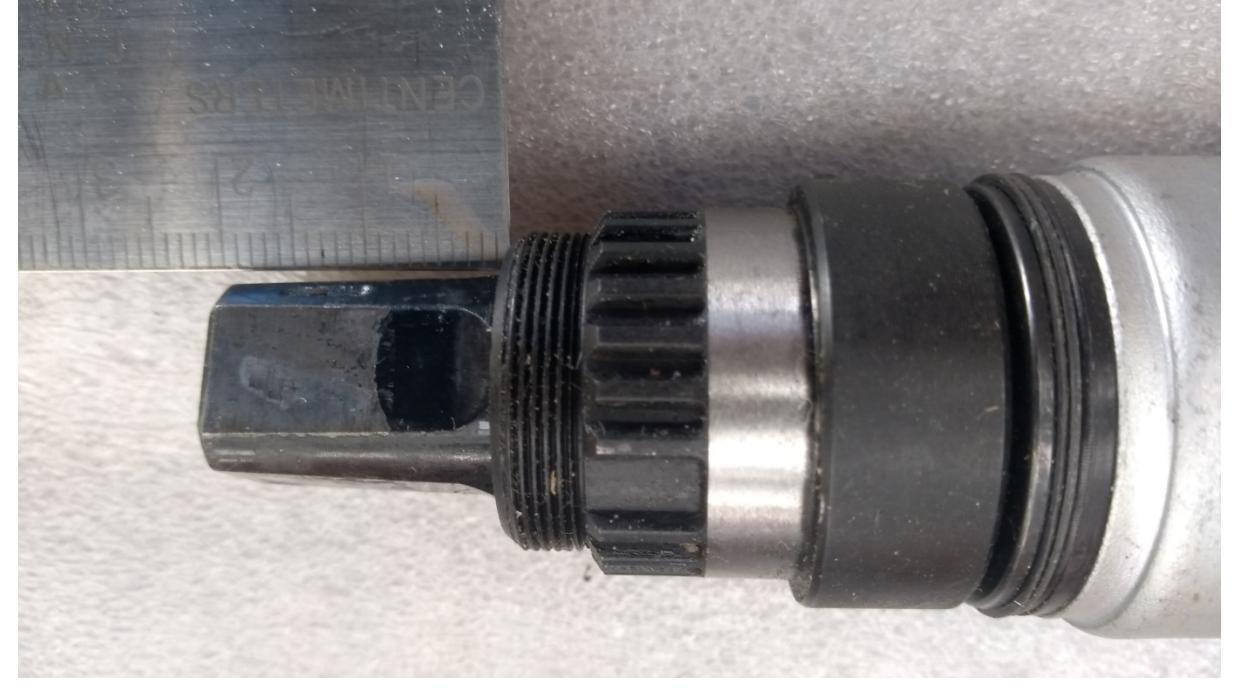
5) Correctly assembled splined hub: 19mm shaft extension on Right-hand side

13) Measure how much length of pedal shaft projects at each end. There should be approximately 19mm of shaft projecting on the right. If this measurement is incorrect, the unit may not be correctly assembled. If there is only approx 15mm projecting on the right, the splined hub is probably not engaged properly onto the output spline of the torque sensor;
